Artifacts in AFM

Kishan K. Sinha
Department of Physics and Astronomy
University of Nebraska-Lincoln

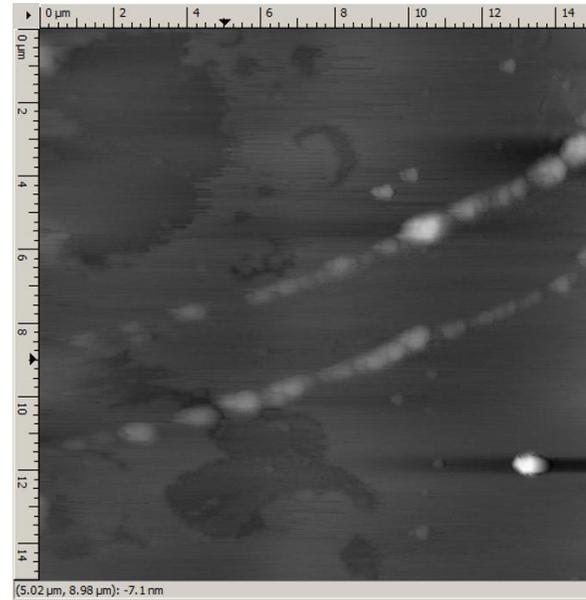
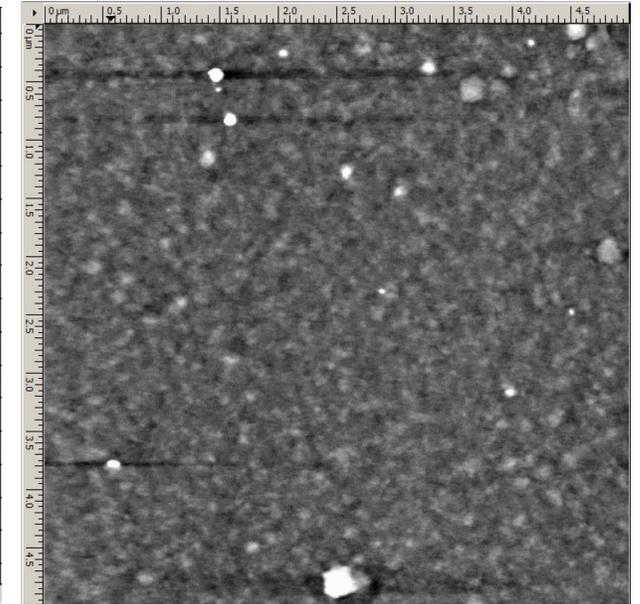
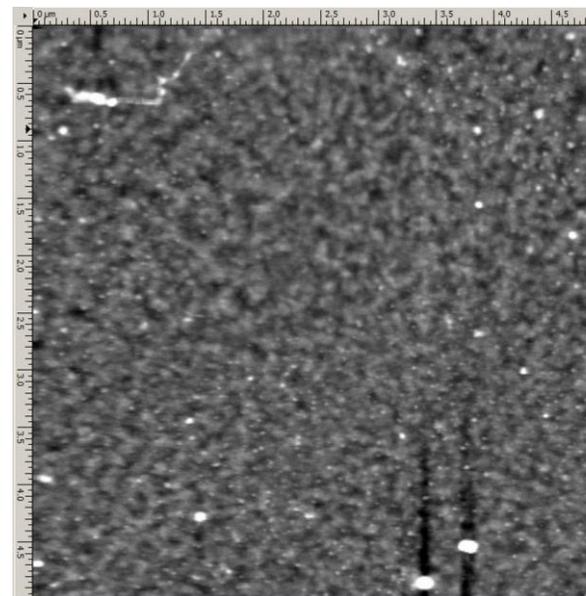
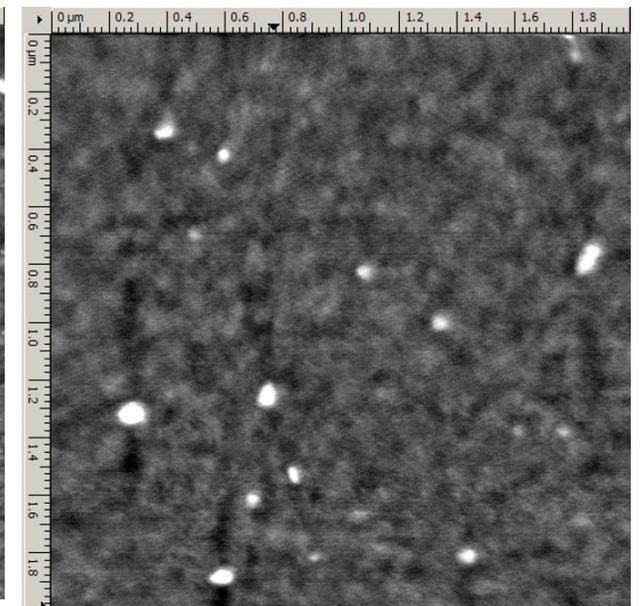
Line levelling during scanning is used to display image without a bow.

However, with this featured turned ON during the scanning followed by image processing results in streaks in the scan direction originating at sites substantially higher than surroundings.

To eliminate these streaks, turn of the “line levelling” feature during scanning and then process the resulting image in usual manner.

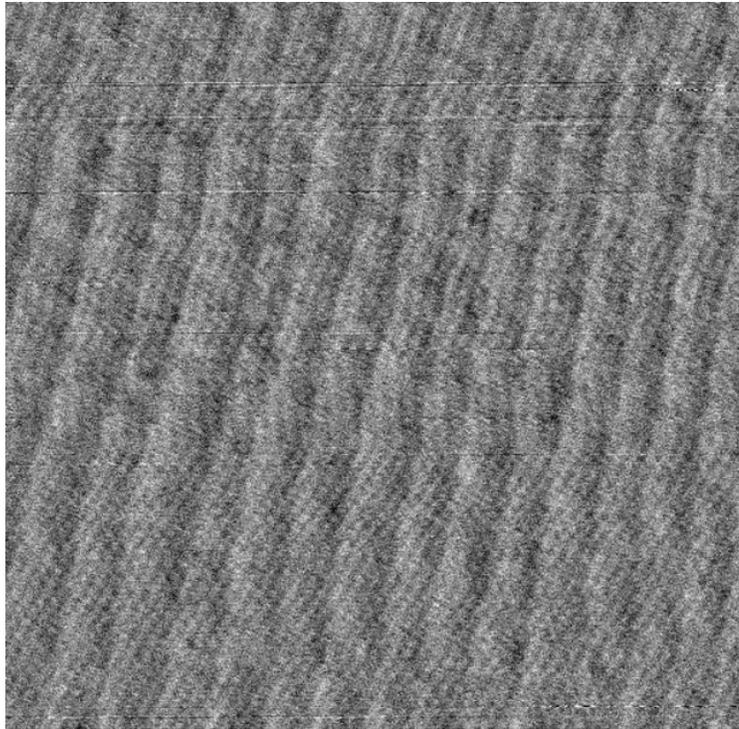
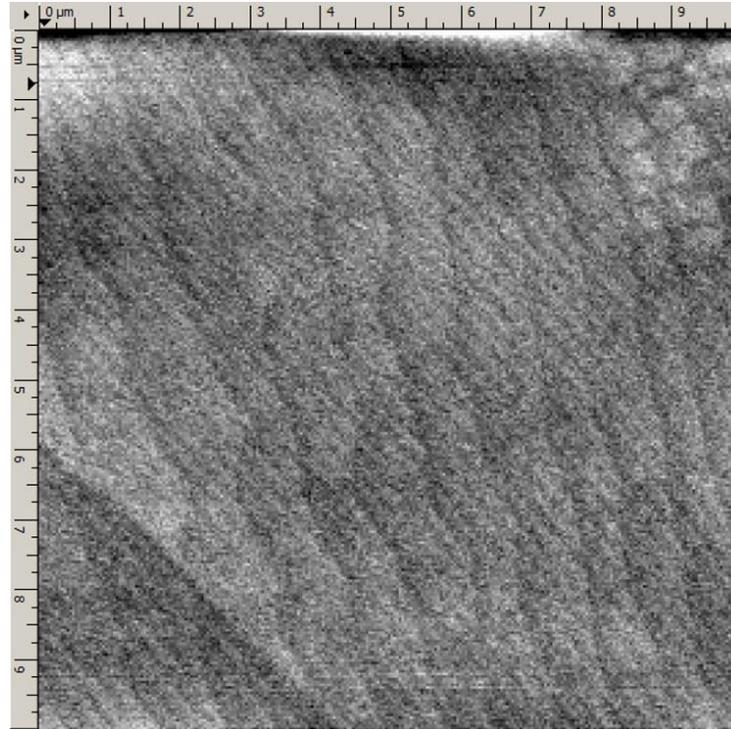
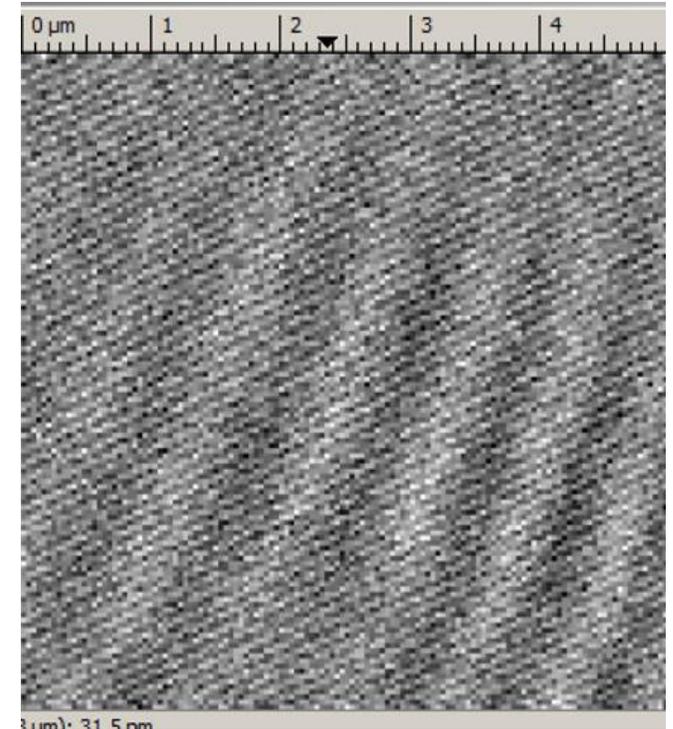
Electronic noise

Artifacts from electronic noise appear as oscillations or repeating patterns.

Often arises due to lack of grounding or broken electronic components in the system.

Can be overcome by changing the scan rate, frequency or GPID parameters, ensuring a proper ground or changing specific electronic components.

Images below exhibit the effect of not having the ground wire attached to the sample stage.

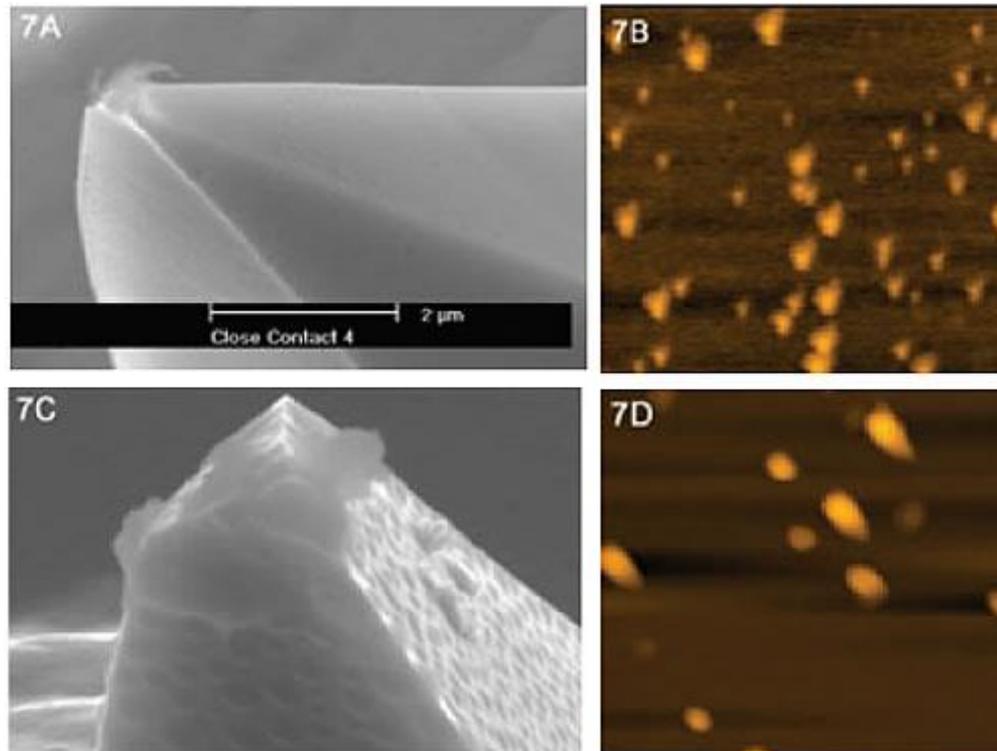
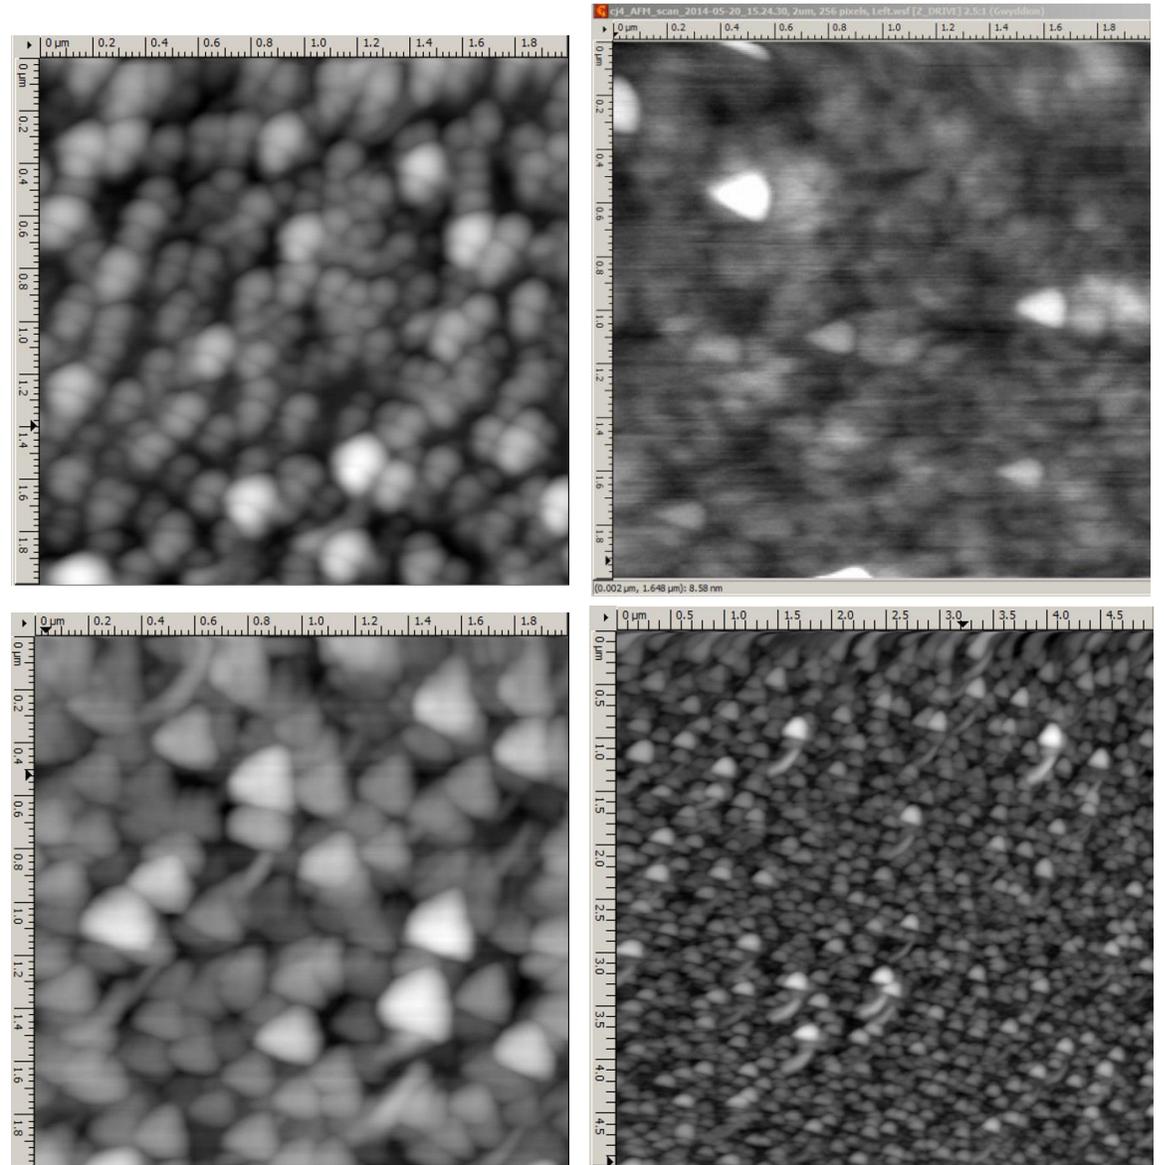
Broken or Chipped tip

If the surface being scanned has features much smaller than the dimensions of the tip, multiple images are usually seen.

A chipped tip often manifests itself in the form of triangular patterns.

Chipping of tip can occur due to fast tip approach.

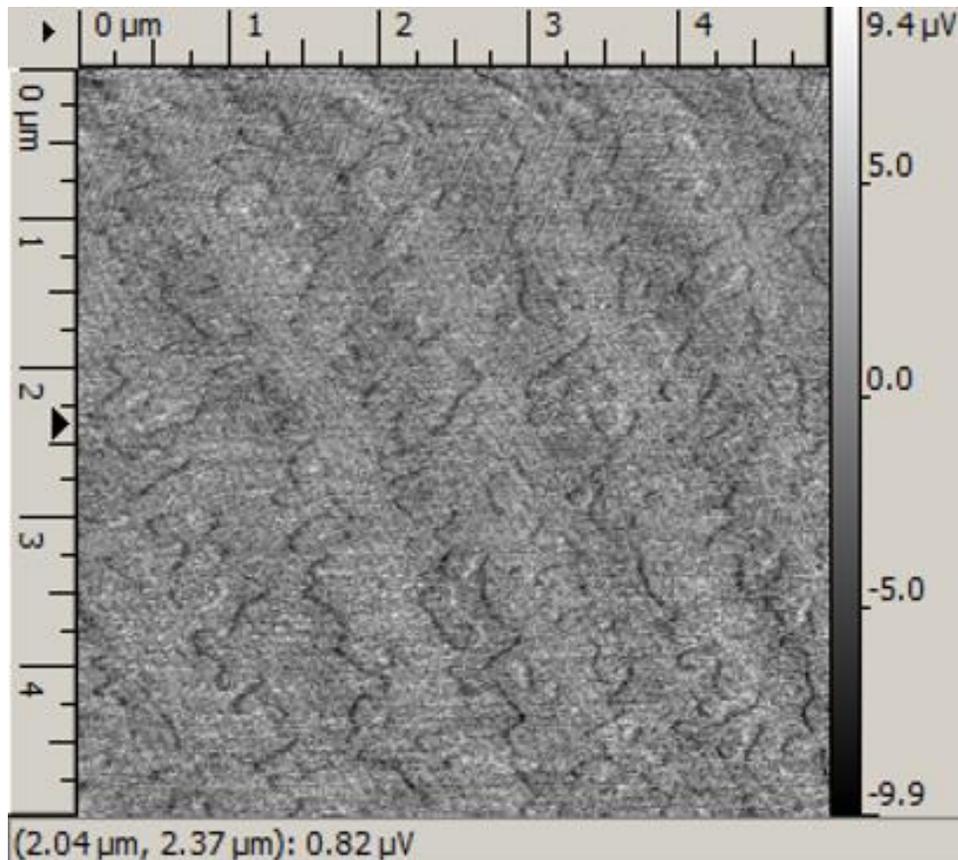
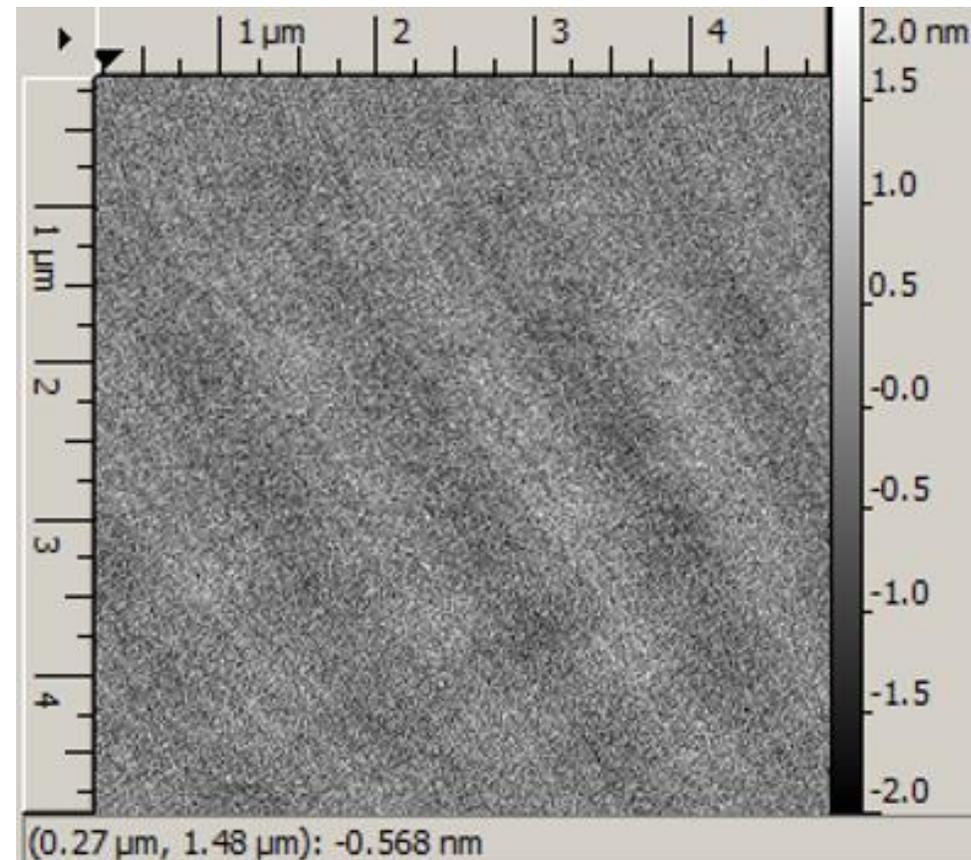
Interference

Occurs due to interference of laser beam reflected off of the cantilever or the sample surface in the immediate vicinity.

Results in low frequency undulations on the image. The period of these oscillations is typically equal to the wavelength of the laser light.

To get rid of this artifact, move the tip to a different location on the surface.

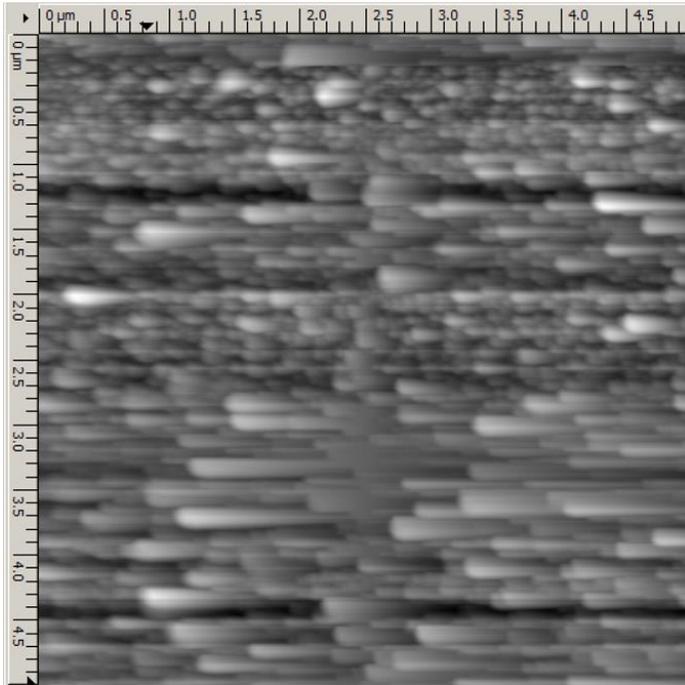
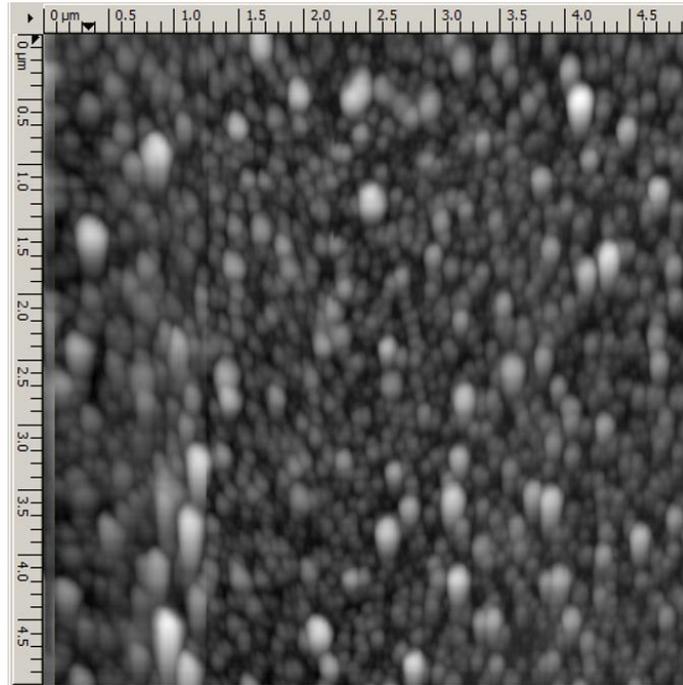
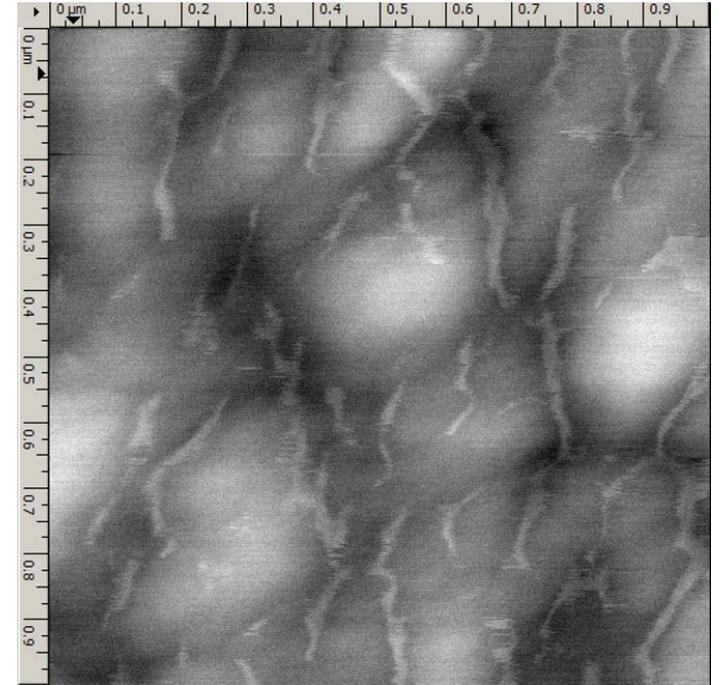
Surface contamination

Contamination of the surface by fingerprint, oil film, etc. can cause artifacts such as smearing of the features or streaks in regions with sharp features as the tip may drag/pull material while scanning. Such artifacts can be eliminated by cleaning the sample.

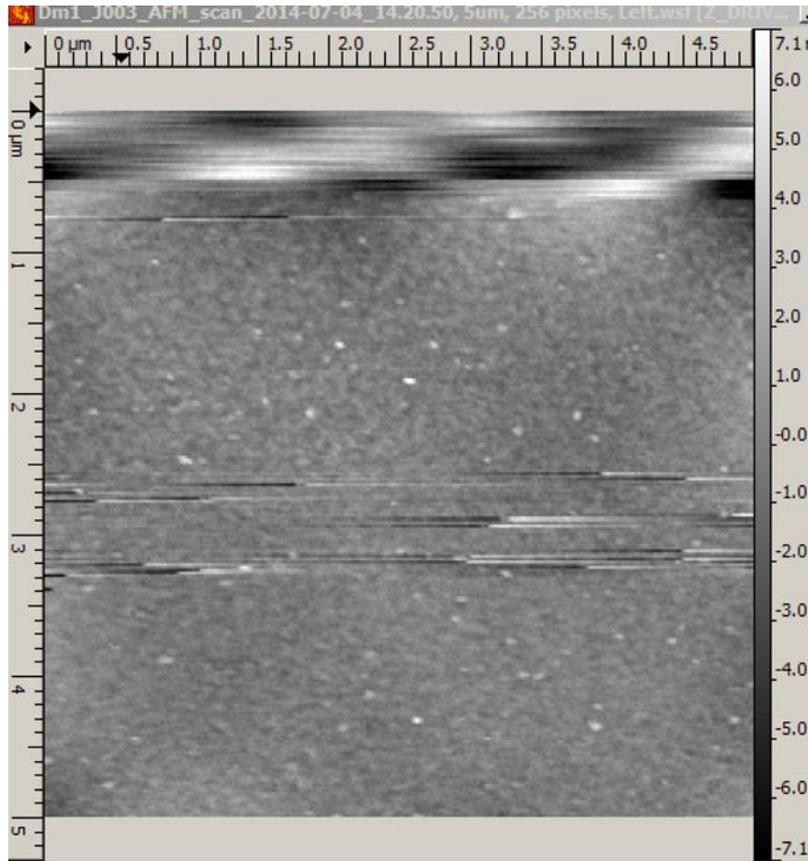
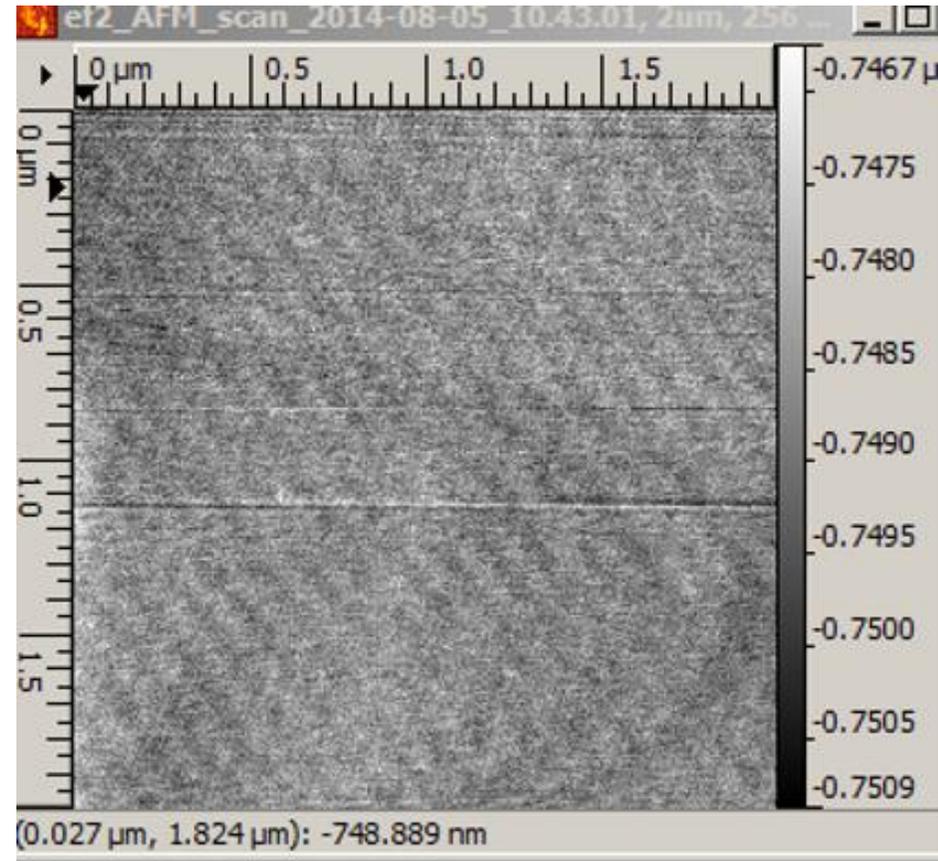
Vibrations

Acoustic and floor vibrations can induce several kinds of artifacts in the form of long streaks across the whole scan, smearing of sharp edges, decrease in contrast, etc.

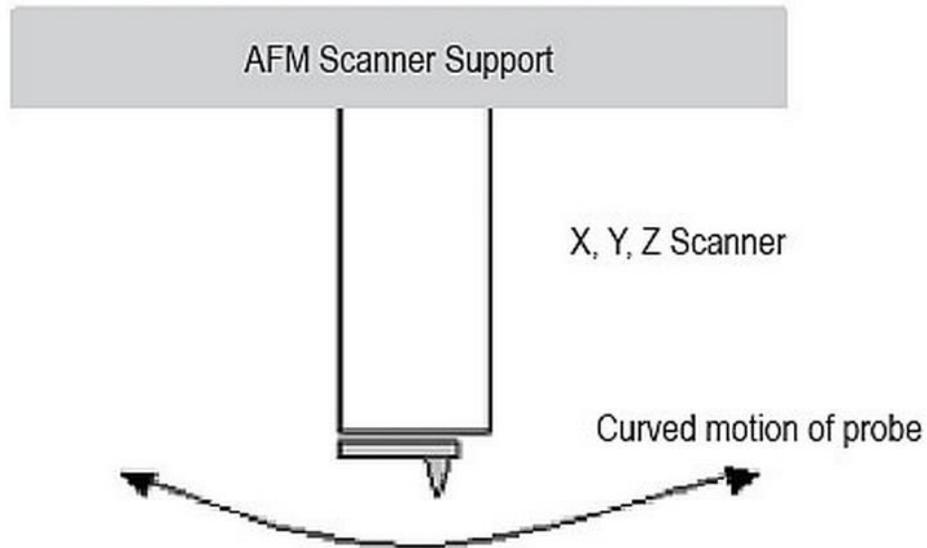
Background Bow/Tilt

The piezoelectric scanners move probe over a curved trajectory. The curved motion results in a “bow” like pattern in the AFM image.

If the probe is not perpendicular to the surface a large planar background is observed, also known as “Tilt” is observed.

These artifacts can be eliminated by subtracting the background from the image. This is called as “levelling” or “flattening” the image.

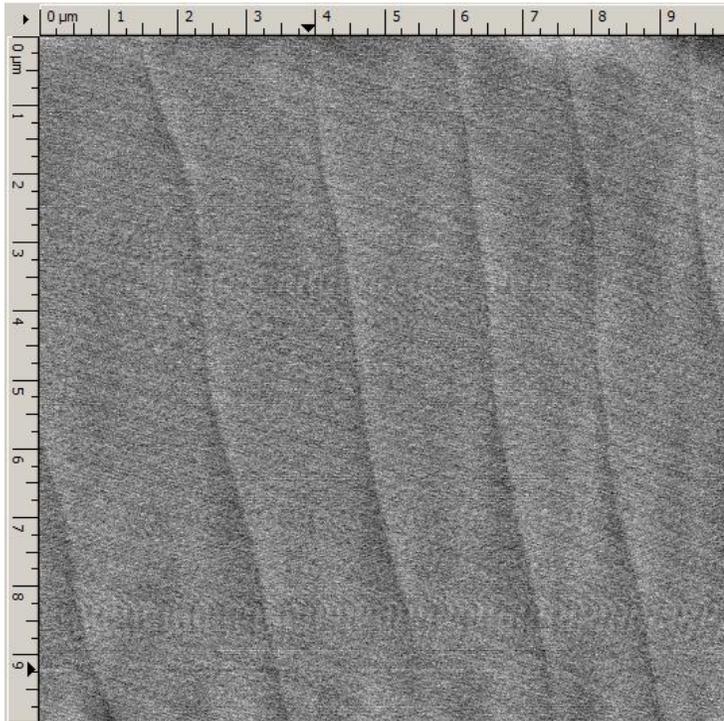
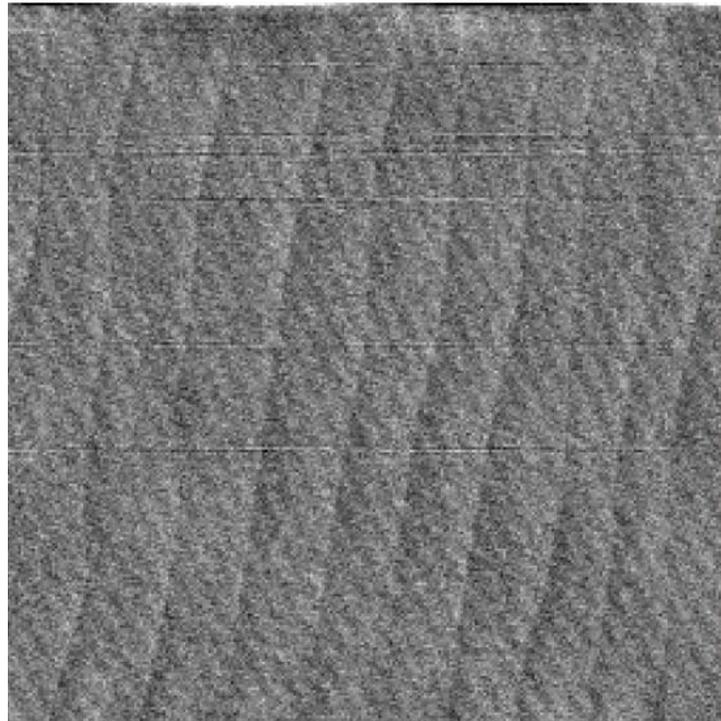
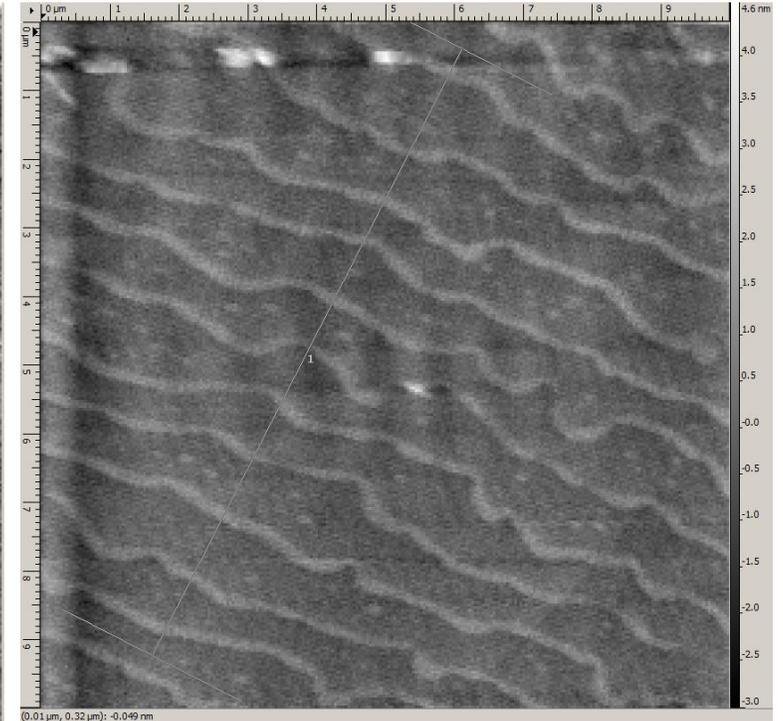
Hysteresis

Unlike other artifacts, hysteresis enhances the image especially at edges by increasing apparent distance across the edge. However, such artifacts usually lead to erroneous measurements. This can be fixed through PID parameters.

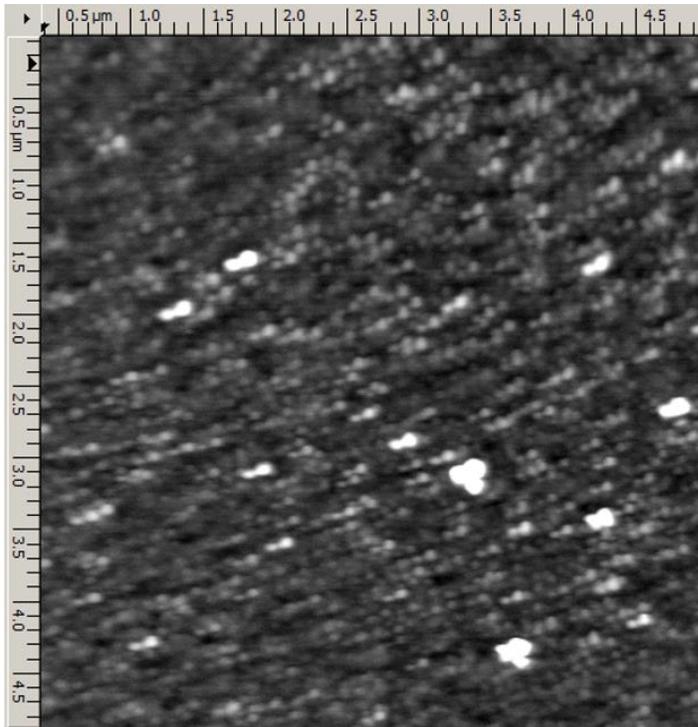
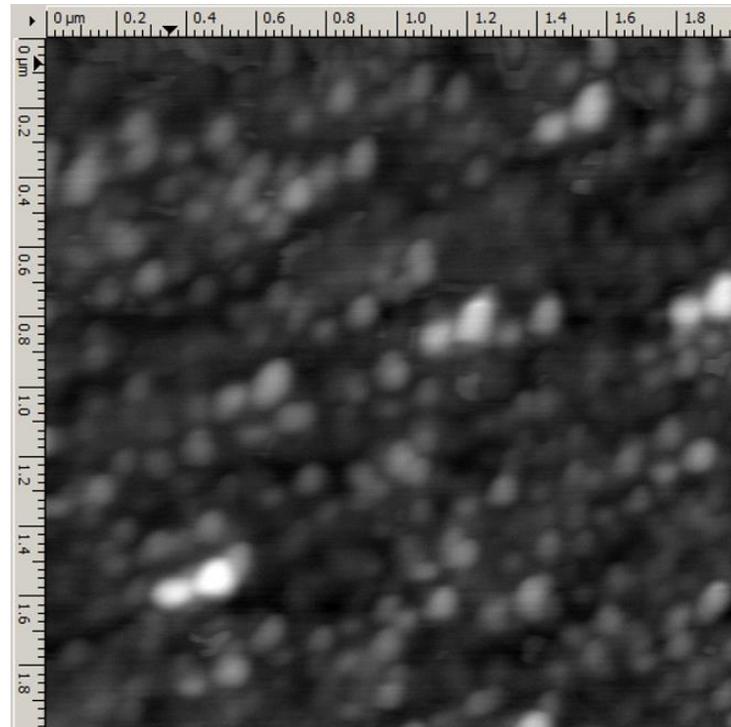
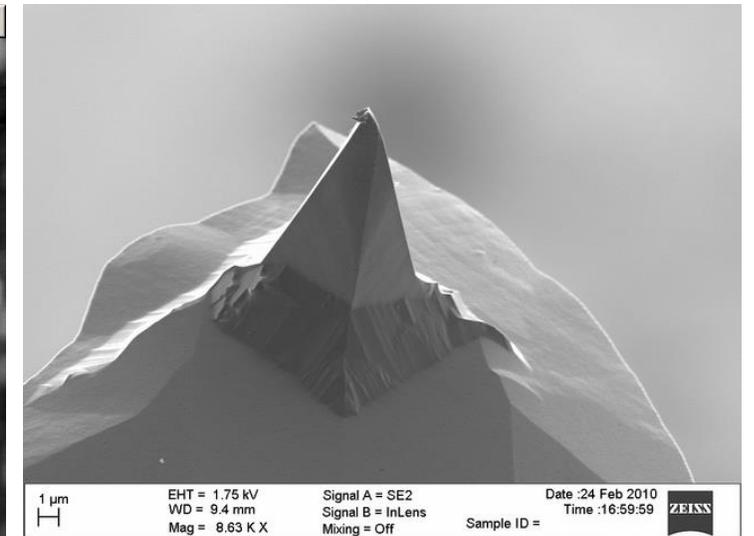
Contaminated tip

A contaminated tip usually results in multiple repetition of surface features. Sometimes it could also lead to emergence of triangle-shaped particles (as are observed with a chipped tip) in the image.

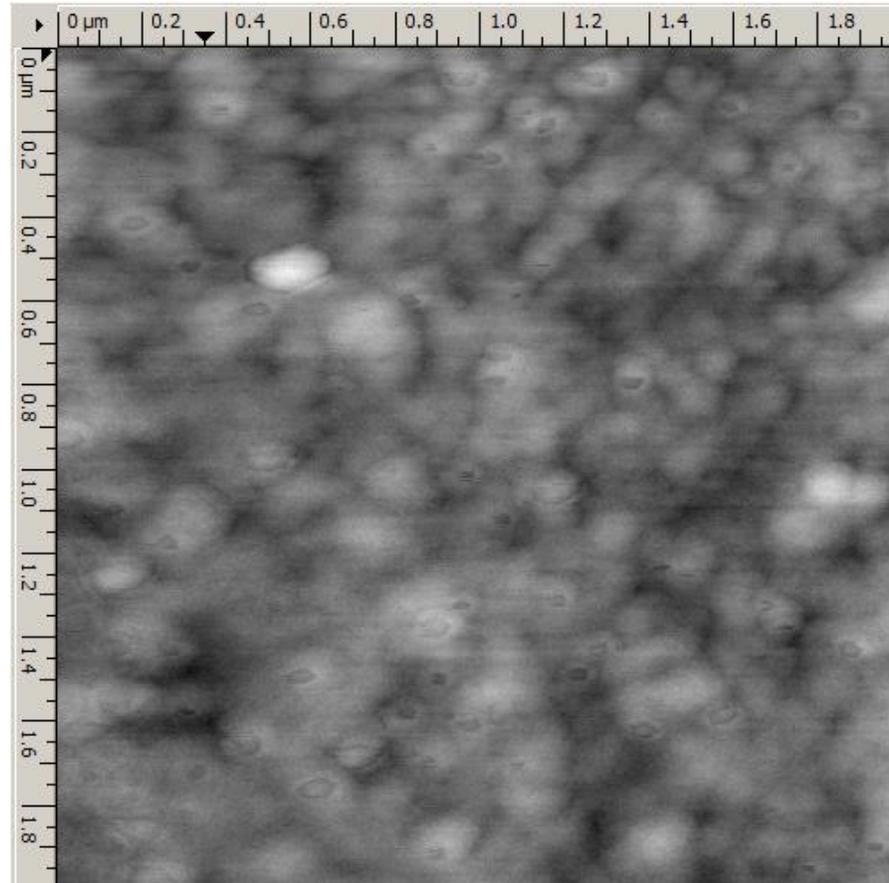
High frequency ringing

Ring-like features are observed in the image if while scanning the cantilever is vibrating at a frequency higher than its resonance value. Lowering the frequency of vibration solves this problem.

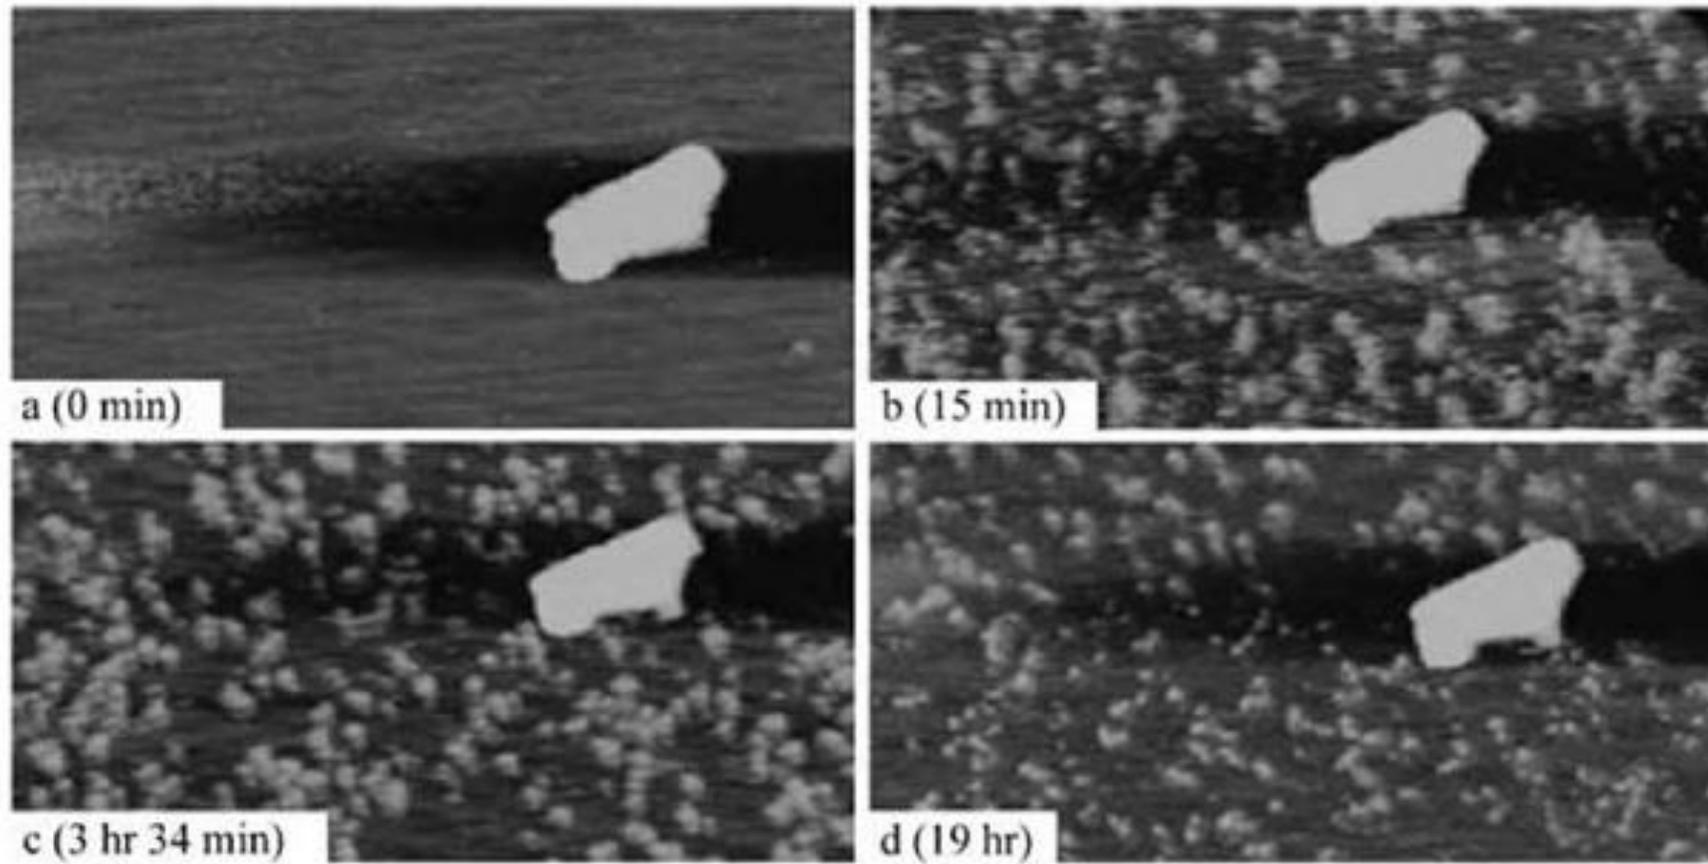
Scanner Drift

This causes distortion in image due to variation thermal response of the piezos. The image appears to be curved in the beginning (common) as well as during the scan.

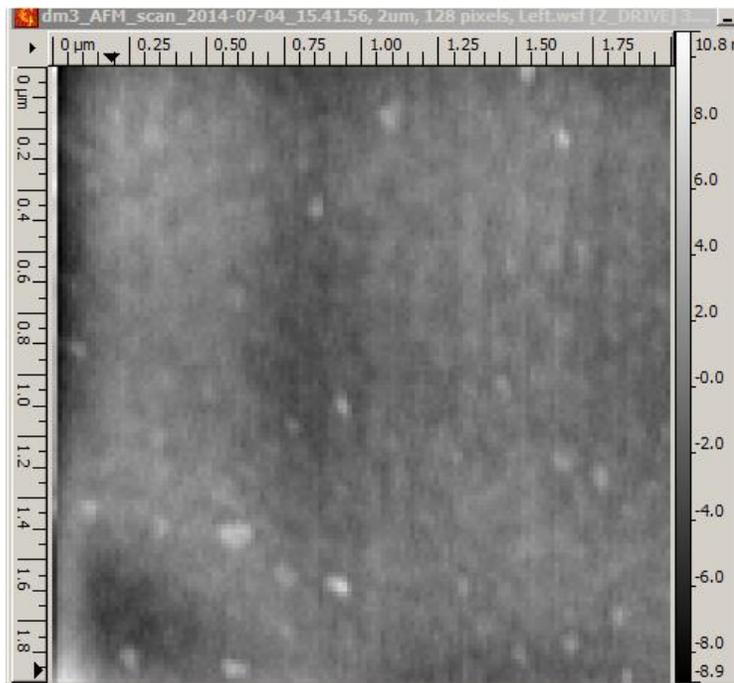
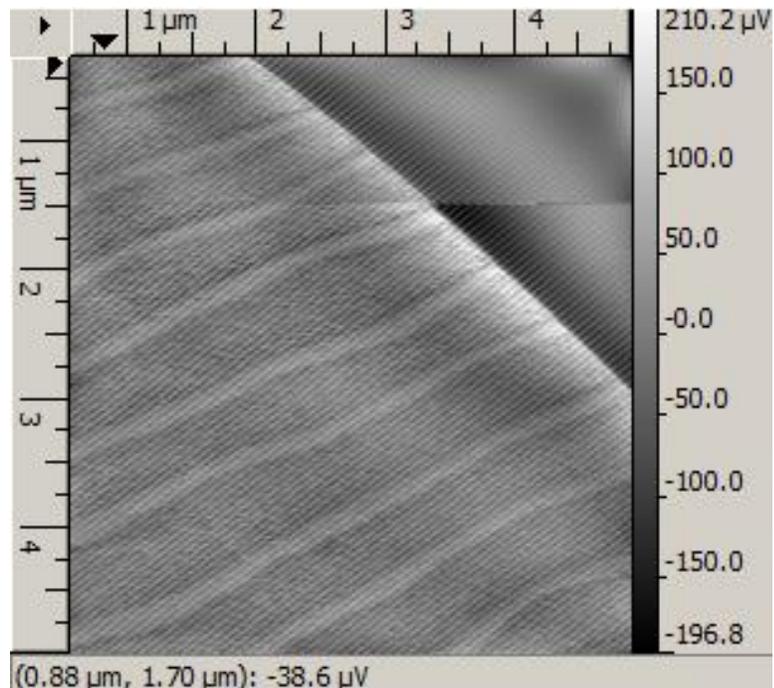
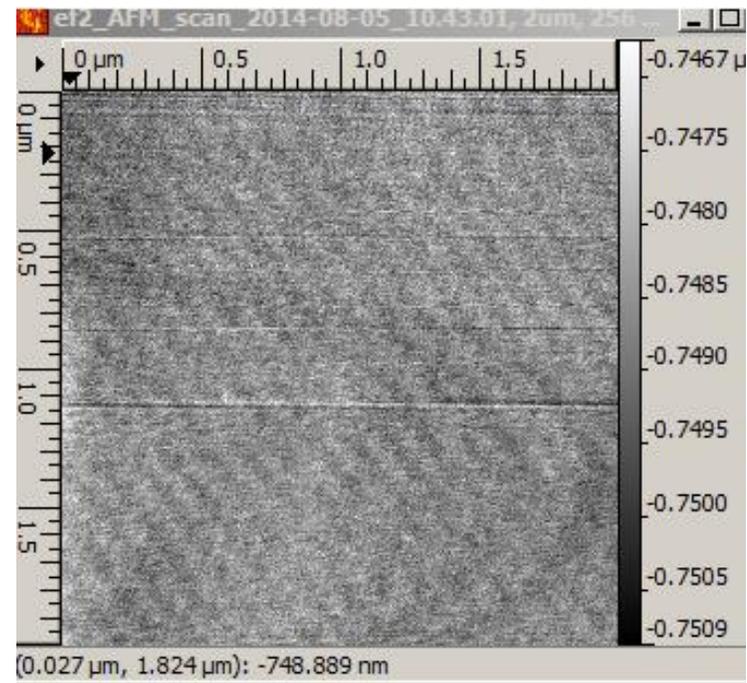
Lack of proper re-centering

Shows up in the form of partly textured and partly blank image
