# Artifacts in AFM

Kishan K. Sinha  
Xiaoshan Xu's group  
Department of Physics and Astronomy  
University of Nebraska-Lincoln

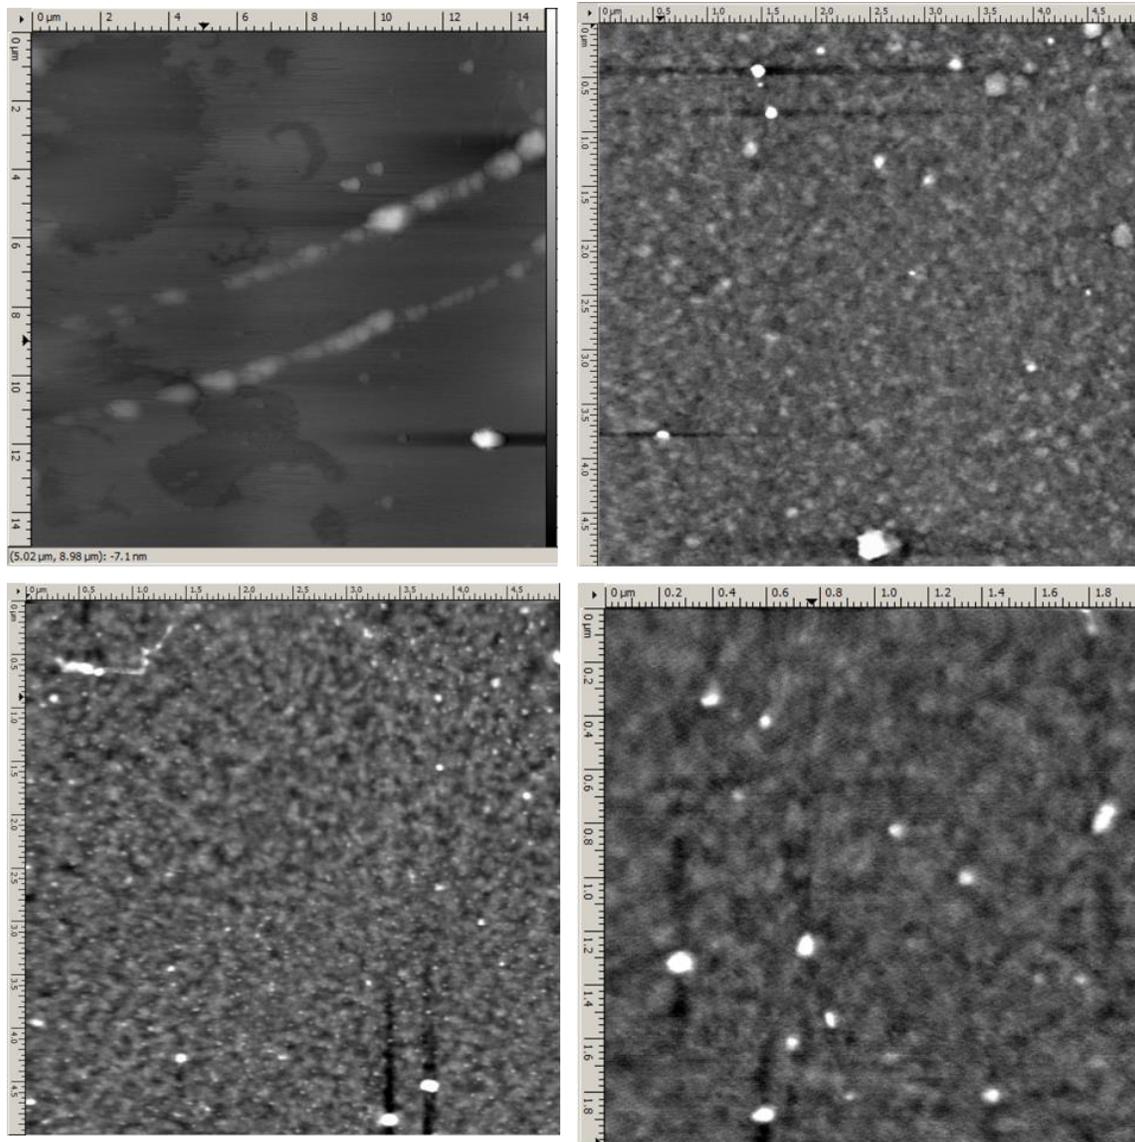
Below are a few images that exhibit artifacts induced by applying line-leveling without excluding particles on the surface.

Fig. 1: Artifacts introduced when large particles are not excluded from line-levelling process

Such artifacts can be avoided by applying line-leveling selectively. This is done by selecting specific regions on the image that must be excluded from the process of determining and subtracting background followed by application of line-leveling. Such regions would include particles or other prominent features on the surface. All of the AFM image processors come with the option of selectively applying line-leveling and area/surface leveling.

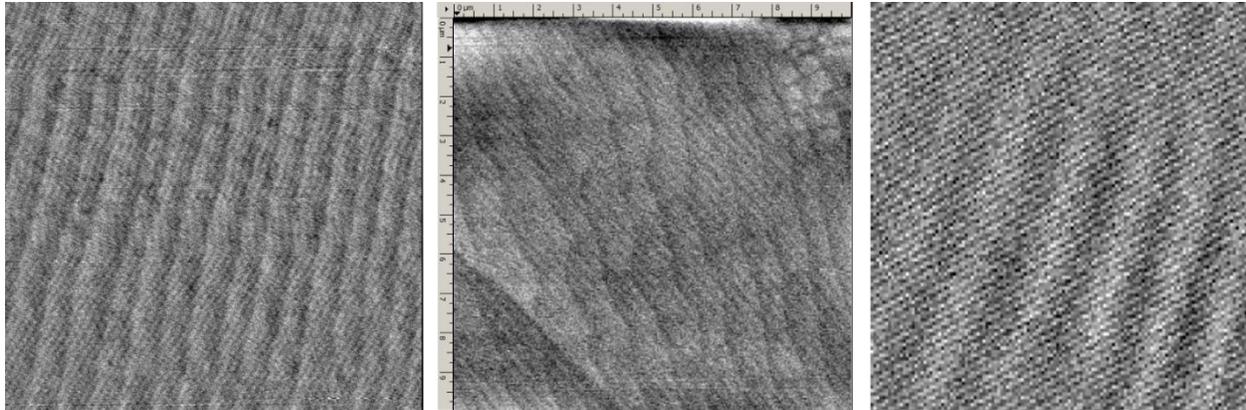
Images below exhibit the effect of not having the ground wire attached to the sample stage and/or having high gain value. Note that images are also ridden with artifacts other than high frequency oscillations. All of them will be addressed as we proceed.

Fig. 2: AFM scans of step-terrace morphology on 0001 surface of alumina. The non-uniform lines are the steps whereas overlying uniform and periodic high frequency lines are the artifacts. In the third image, severity of artifacts render steps completely invisible (low frequency oscillations are not steps but artifacts from interference).

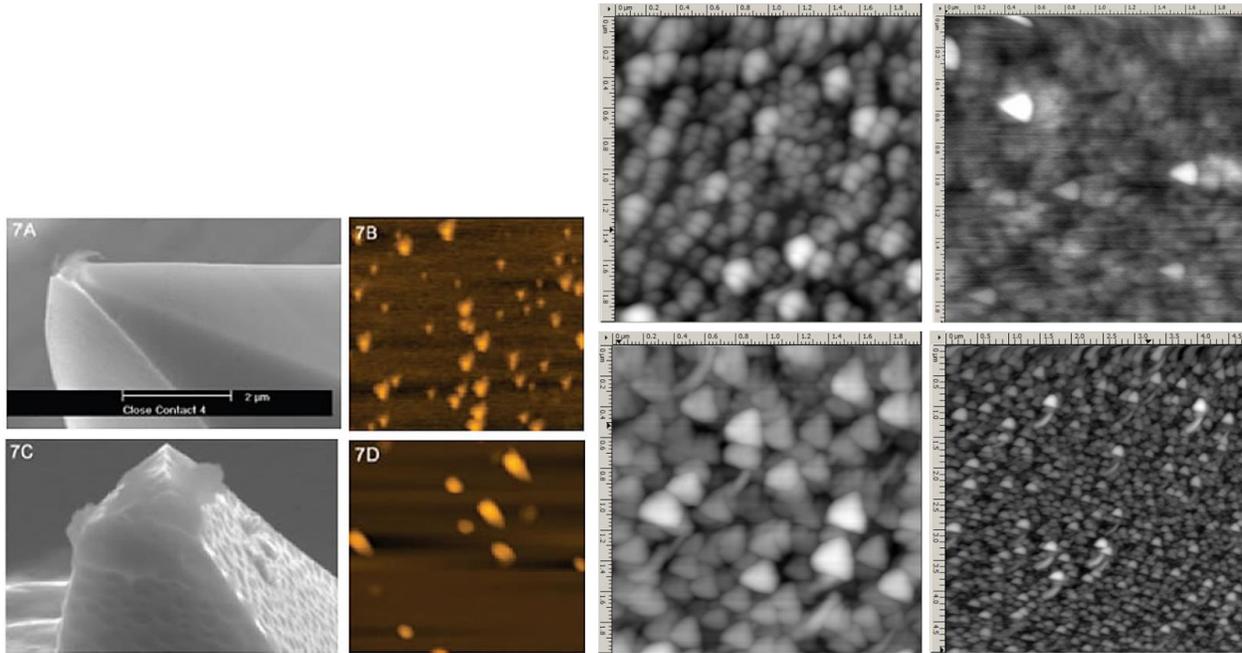
For example, if the tip has a triangular cross-section and is damaged, particles with dimensions comparable to that of the tip will appear as triangular objects, as shown in the images below. If the tip is conical, the shape of particles in the scan will be different. It is quite possible to encounter other peculiar shapes depending on the way the tip is broken.

Fig. 3: Artifacts due to chipped/broken tip.

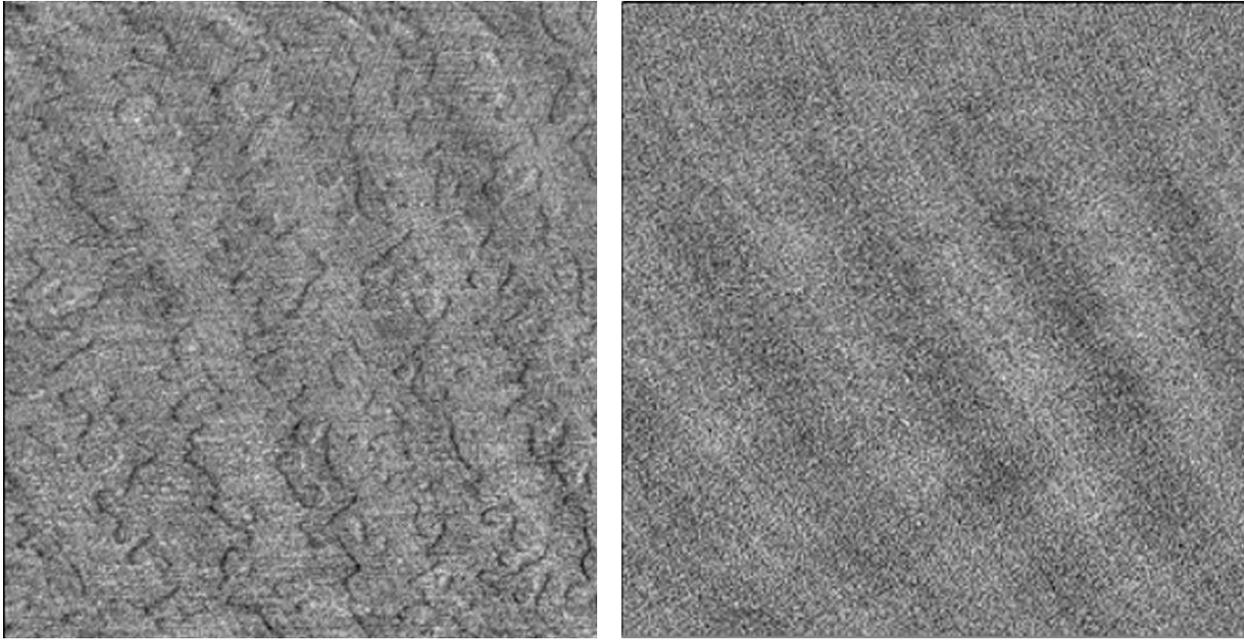
If the surface being scanned is flat, the laser beam reflected off of the cantilever and some part of the surface may interfere. This interference introduces artifacts in the form of low frequency undulations on AFM image. Below are a couple of examples where the interference dominates the actual underlying surface features. The period of these oscillations is typically close to the wavelength of the laser light.

Fig. 4: Low-frequency oscillations induced due to interference of reflected off of cantilever and sample surface.

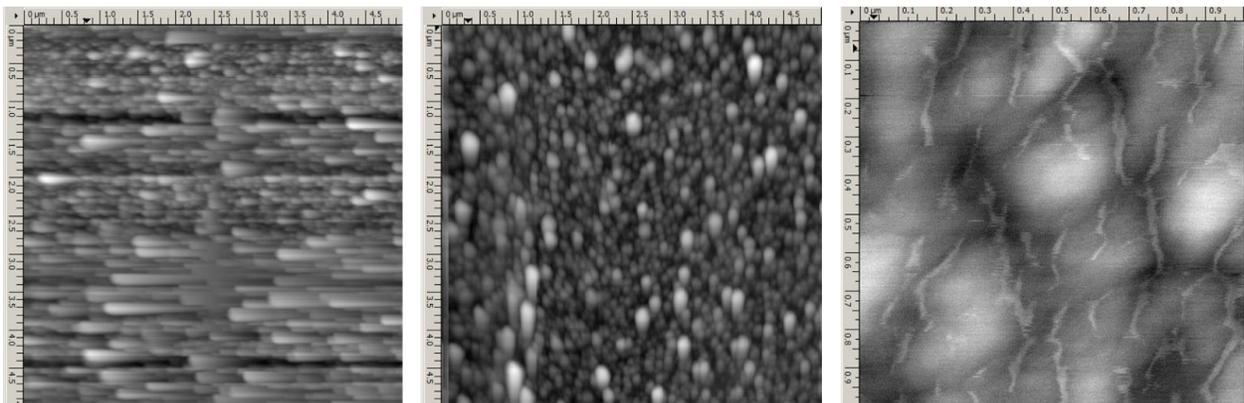
Contamination of the surface by fingerprint, oil film, etc. can cause artifacts such as smearing of the features or streaks in regions with sharp features as the tip may drag/pull material while scanning. Such artifacts can be eliminated by cleaning the sample with a suitable solvent.

Fig. 5: Artifacts introduced due to interaction of AFM probe and contaminated surface.

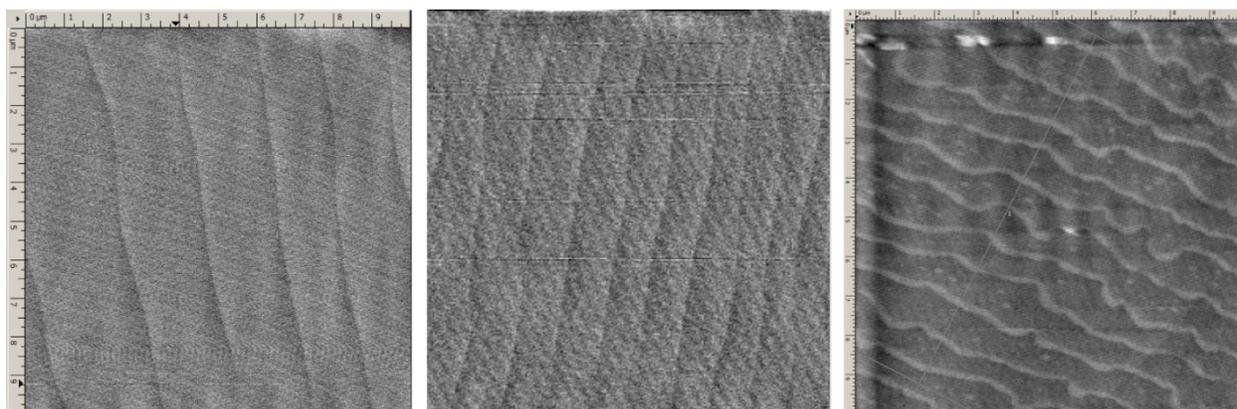
Ceramic piezo-scanners often exhibit hysteresis meaning they respond differently when scanning the over the same feature in different directions. Hysteresis along z-direction can influence the tip motion across an edge or a step leading to erroneous measured heights. Unlike other artifacts, hysteresis along z-axis tends to enhance the image especially at edges by increasing apparent contrast and hence distorting the actual difference in heights. Hysteresis can be effectively suppressed by reducing the scan speed. If this does not work, one might have to resort to optimizing the GPID parameters. Images in fig. 6 exhibit the typical enhanced contrast across the 0001 alumina steps. Notice that the first two images also exhibit the electronic noise suggesting lack of proper sample grounding whereas the third one exhibits artifacts due to interference in addition to hysteresis.

Hysteresis along x (or y) direction generally appear as a line across the image in y (or x) direction. Third image, which is already processed to remove background, exemplifies this where the scan direction is along x-axis and hysteresis in this direction results in a line on the left side of the image. A fix to this problem would include optimization of GPID parameters along with a slow scan rate.

Fig. 6: Enhanced contrast (overshoot and undershoot) at edges due to hysteresis in piezo-scanners.

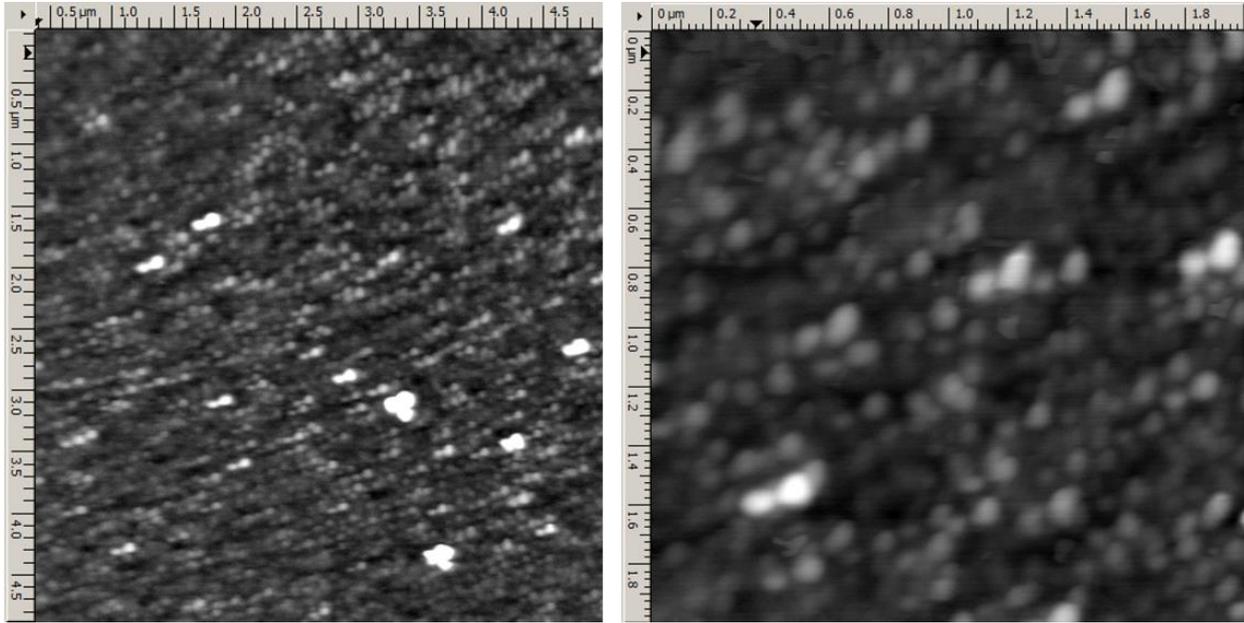
A tip may gather dirt while scanning a dirty surface. These dirt particles act as secondary tip and usually result in repetitive pattern with peculiar shapes on AFM image. The details of particle shape on image depend upon the resultant geometry of the dirty tip. Sometimes it could also lead to triangle-shaped particles (as are observed with a chipped tip) in the image. If luck is in favor, one could get rid of dirt by vibrating the tip vigorously or scanning a hard surface. However, changing the tip is usually a better option.

Fig. 7: Repetitive patterns due to contaminated tip.

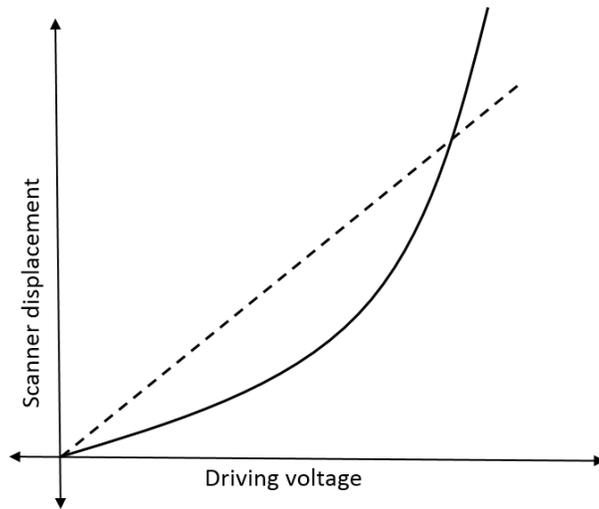
Non-linear response of a ceramic piezo-scanner

Fig. 8: Examples of non-linear response (a) and trajectory of ceramic piezo-scanners (b).

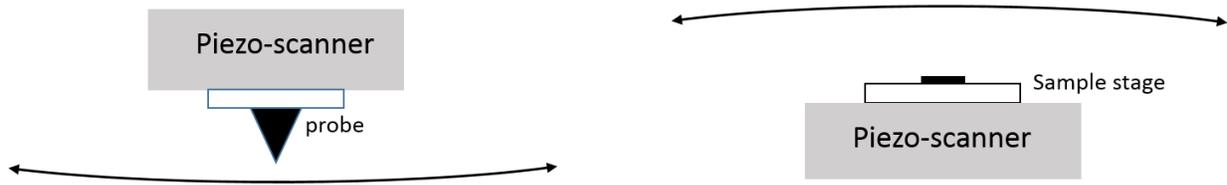
(b)

Typical curved trajectories of probe (when scanners are attached to the probe) or sample stage (when scanners are attached to the sample stage).

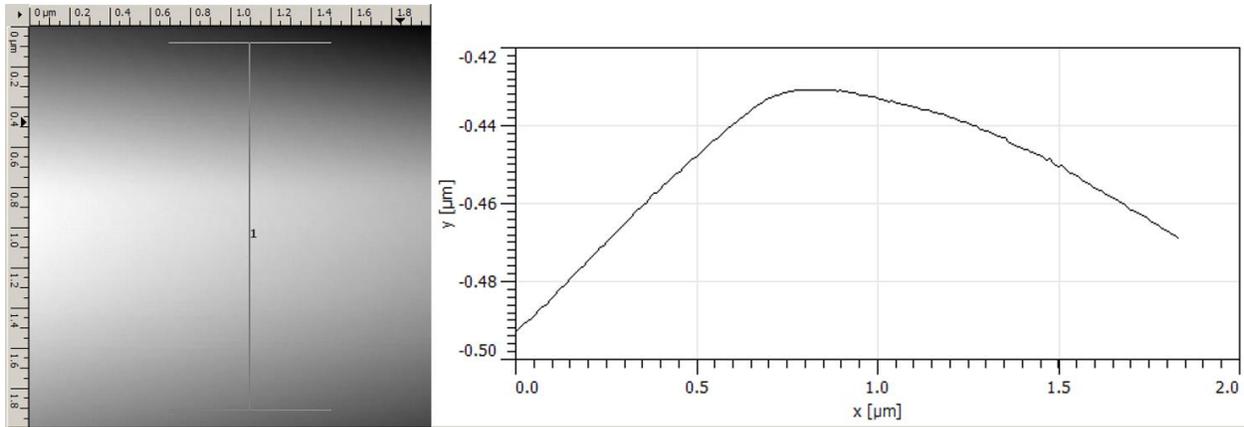
Fig. 9: A typical bow (in this particular case, the piezo-scanner is attached to sample stage and AFM probe remains stationary)

Ceramic piezo-scanners are non-linear devices, i.e. they respond non-linearly to applied voltage. Due to this non-linearity, piezoelectric scanners move AFM probes over curved trajectories. Such a curved motion naturally results in a typical large “bow” like background in an AFM image. This background could range from several nanometers to a few microns, thus, making it impossible to view finer surface features during an ongoing scan. This can be dealt with by turning ON the line-leveling feature located somewhere on AFM software. This feature subtracts bow *line-by-line* while the data is being accumulated. This, however, is only to facilitate live viewing and does not alter the original data which includes bow. One can eliminate the bow post-data acquisition using selective (to avoid streaks) *line-leveling* option in image processing software.

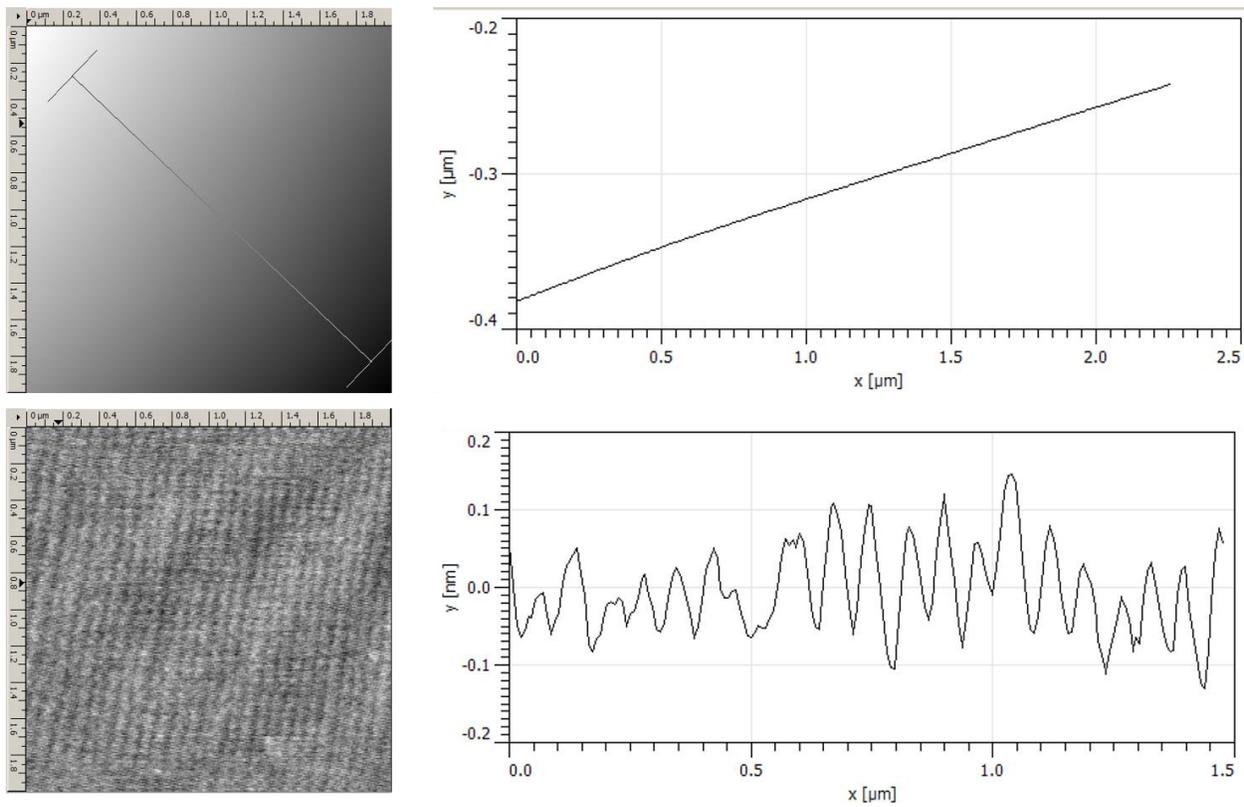
Fig. 10: A typical “tilt” and image after subtracting the background. Notice that the tilt adds a large background (measuring in microns), however, the details measuring fractions of a nanometre are easily retained after background subtraction (area-leveling).

When the probe is not perpendicular to the sample surface, another type of background, known as "tilt", is introduced during data acquisition. This can be easily eliminated using *area-leveling* during image processing.

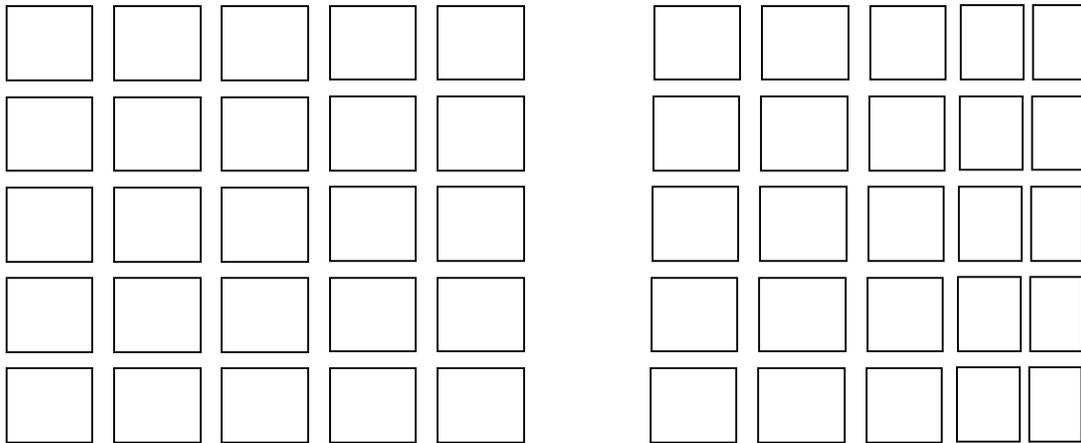
Fig. 11

As stated above, ceramic piezo-scanners are non-linear devices i.e. they move non-linearly to applied voltage as suggested in the figure below. If this non-linear nature of scanners is not accounted for in the  $xy$  plane, the image appears distorted. The effect becomes obvious when the surface contains even periodic pattern and will be present in scans of uneven surfaces but may not be as obvious. In order to eliminate such artifacts, we need to *linearize* the scanners. This can be achieved in two ways:

Distortion due to non-linear piezo-scanner

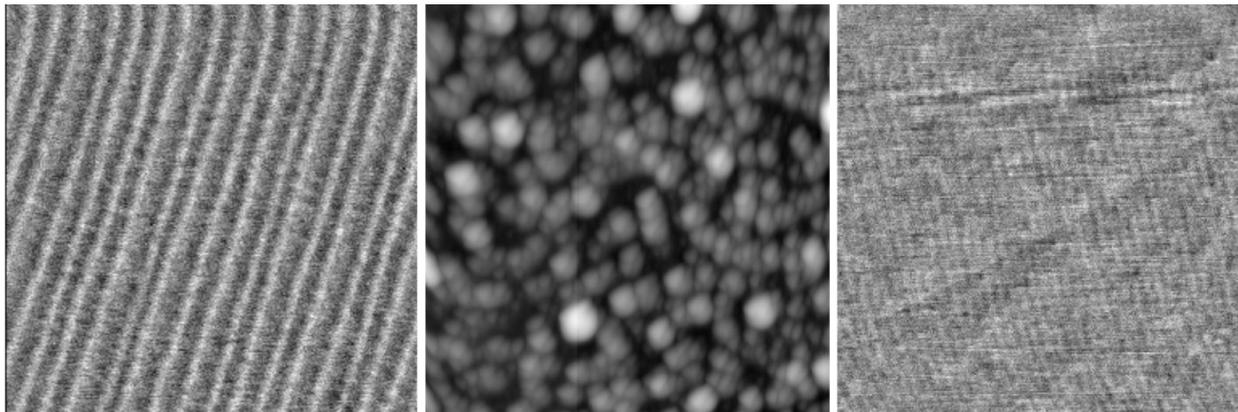
(a) Creep visible on upper-half of the image (in the beginning of the scan)

(b) Creep visible at left hand side of the image where scanning began. Creep is more apparent when the surface has regular patterns such as parallel lines.

(c) Creep visible throughout the image along with other artifacts.

Fig. 12: Distortions introduced by scanner drift or "creep".

Piezo-scanners are electro-mechanical devices and exhibit a certain lag in response to the applied (or driving) voltage. When the variation in driving voltage is very fast, this lag renders the scanner unable change its position as rapidly as the driving voltage. This effect is known as "creep" and it manifests as a peculiar distortion in the image. If a surface has a pattern of parallel lines, then creeping shows up as bending of lines in the image. This bending is common in the beginning of a scan but could persist throughout the image depending upon the scan rate and surface features. Creep also causes drift while zooming into a specific region of a scanned area resulting as improper centering of the zoomed in region. As a result, the zoomed-in image appears somewhat drifted or not centered as originally intended. This may not be an issue where the scan areas are large but could pose a problem with high resolution scans.

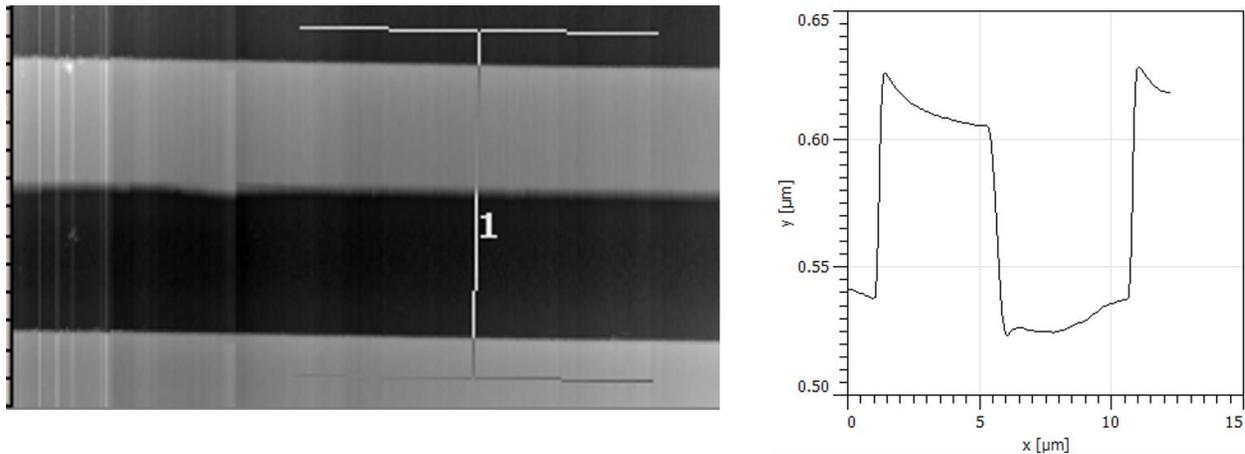
Along the z-direction, creep becomes apparent as overshoots across features with steep gradation in height such as step-terrace morphology on (0001) alumina or (001) STO, etc. These overshoots appear as enhanced contrast and could easily lead to over-estimation of heights of steep features. *Artifacts due to creep can be avoided by scanning at a lower rate.*

Overshoot at an edge

Fig. 13: Overshoot and undershoot across an edge

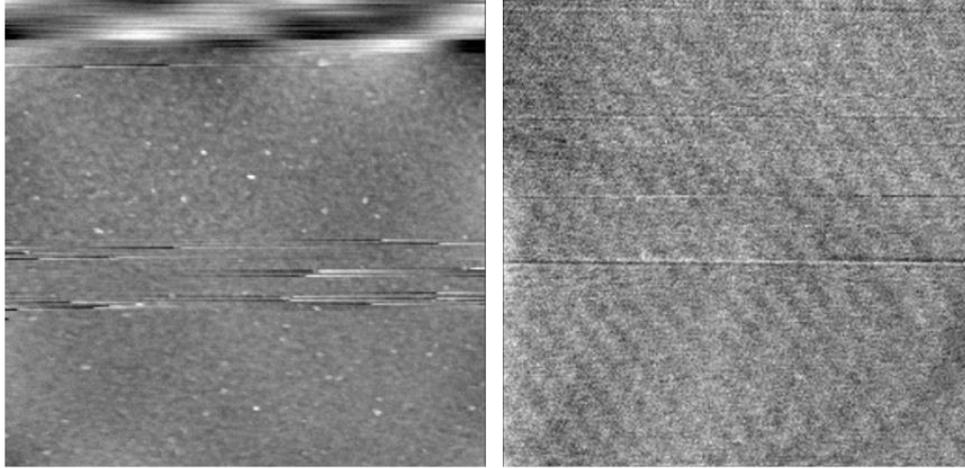
Streaks across an image are usually due to vibrational noise. Similar streaks are observed when scanning condition is changed abruptly during an ongoing scan. Artifact on upper half of the first image is due to failure of probe to track the surface. The second image also exhibits electronic noise and creep.

Fig. 14: Artifacts due to vibrational noise

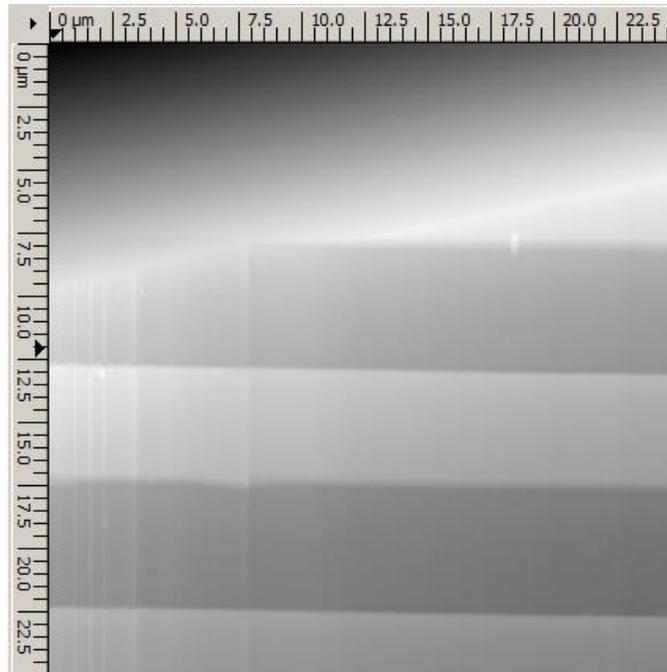
The range of motion of a piezo-scanner is determined by the gain value of the sensor (strain gauge) attached to that scanner. (This gain is different from the gain in GPID parameters). Before beginning the scan, it is imperative to ensure that the sample surface lies at the center of this range. If the surface lies close to any extremity of this range, the probe may go into open loop feedback while scanning. This shows up as a part of the image being completely blank as shown in fig. 15.

Fig. 15: Artifact due to not having the surface at the center of z-piezo scanner range.

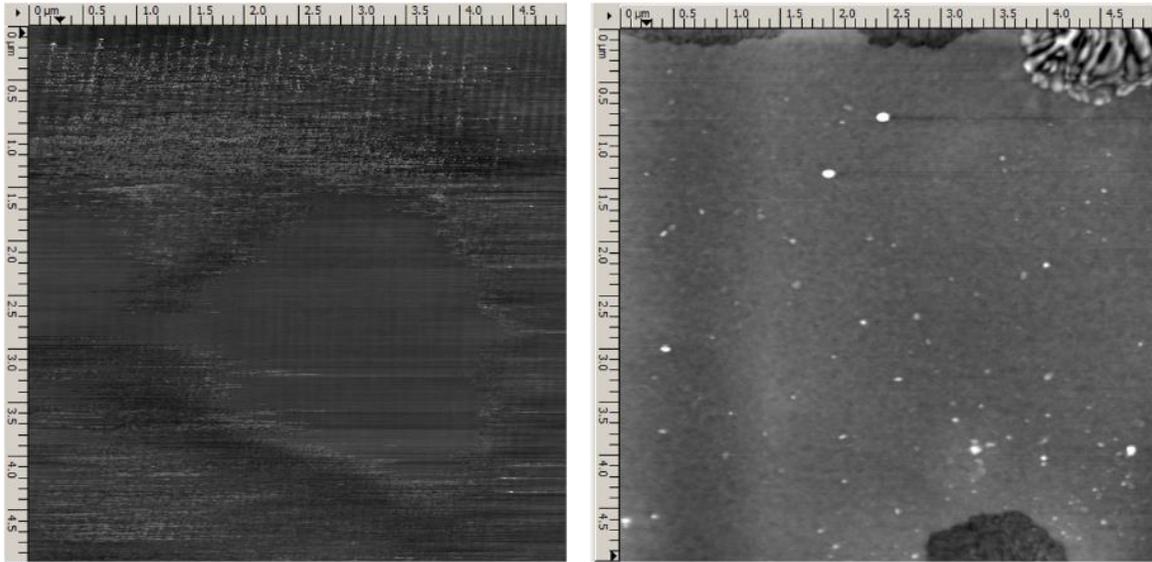
Images below are typical examples of not having optimum GPID parameters. The first image exhibits smearing of features in certain regions of the image. This is due to low gain value for  $z$  piezo-scanner. Whereas the second image demonstrates the effect of low gain value for  $xy$  piezo-scanners (this type of artifact can be eliminated using selective line-leveling along  $y$ -direction). Feedback parameters, which include GPID, determine the response of a probe to the surface features during scanning process. Requirements for optimum response of a probe depend on the type of surface being scanned. Severity of artifacts depend on how far GPID parameters are from optimum values. Along with GPID parameters, other factors that affect image quality are scan speed, amplitude of probe vibration and dampening (in AC mode), deflection (in DC mode), calibration and linearity. All of these parameters are surface specific in AFM.

(a) When the gain is too low, probe cannot track the surface consistently resulting in smearing of features on parts of the image

(b) Effect of not having GPID parameters optimized. Low sensor gain when scanning area is large usually results in appearance of one or multiple broad lines across the image (along y-axis toward left in this image, scan is done along x-axis).
